Management Report

ABC Property Management
Bowling Alley
1443 Lake Avenue, Woodstock, IL

Bowling Alley
1443 Lake Avenue
Woodstock, IL

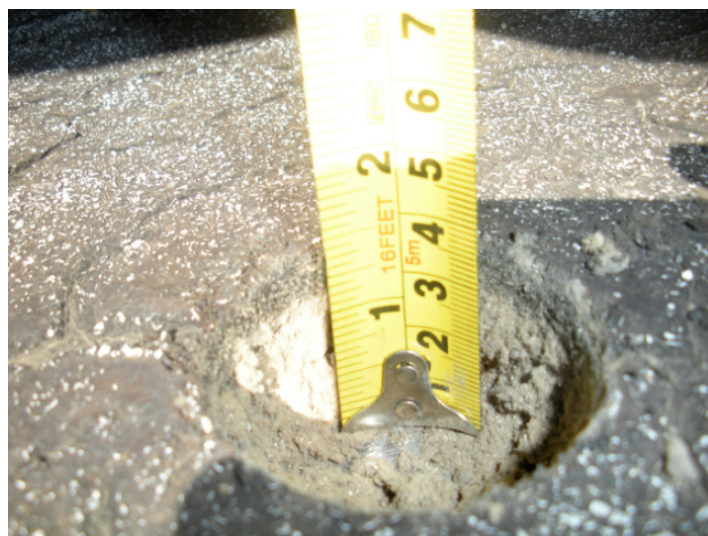
Test Cut 1
Concrete
1/2 Poly
Metal

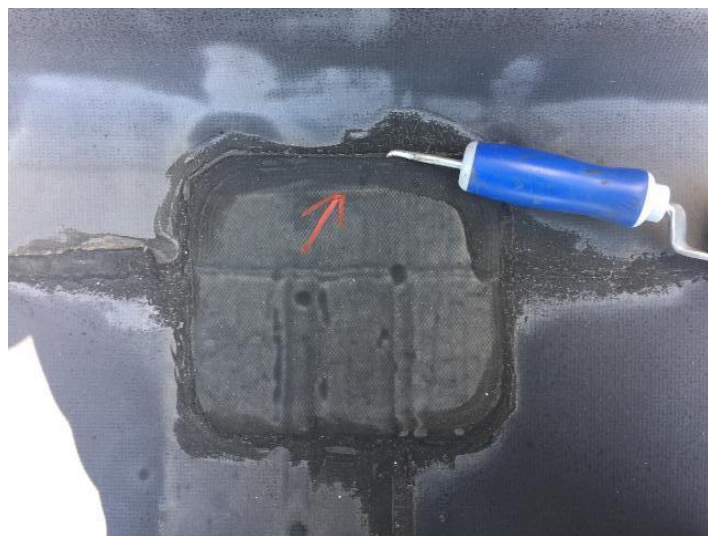
Patched Core Cut 1
This is the picture of the patched core cut.

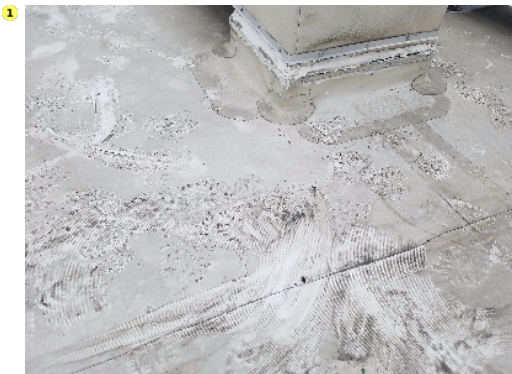
General - Puncture (Emergency)

Quantity: 1 EA

Deficiency:

Puncture

Patch puncture

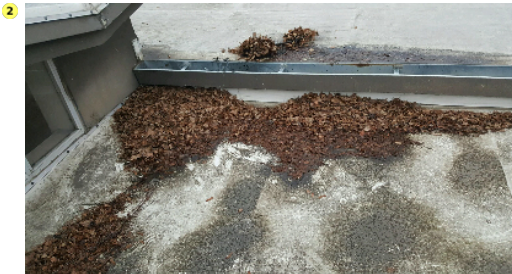
General - Debris (Remedial)

Quantity: 100 SF

Debris on membrane is damaging membrane.

We will remove and dispose of debris and repair damaged membrane.

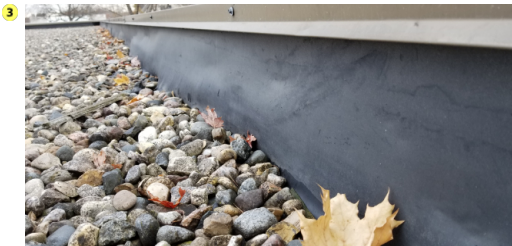
EPDM - Bridging Severe (Remedial)

Quantity: 20 LF

Membrane has begun pulling away from the wall due to shrinkage or failing adhesive. This can allow for condensation to develop and in rare instances can pull the masonry apart.

Membrane is cut open to allow for the material to relax. New material is installed into the angle change per industry standards.

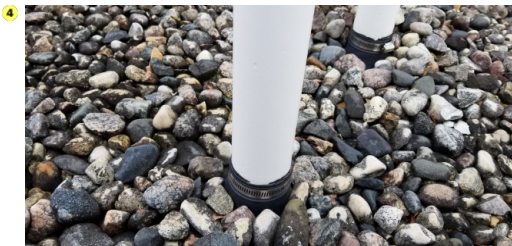
General - Counterflashing Caulk Failure (Remedial)

Quantity: 8 EA

Caulking at counter flashing is failing and allowing water in.

We will remove the old caulking, prime the area and install new NP-1 to ensure water tightness.

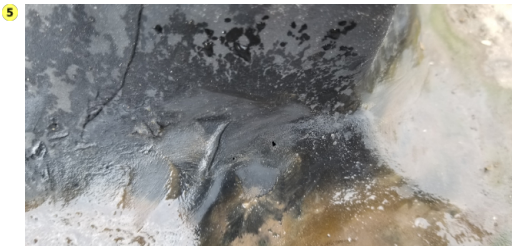
EPDM - *Punctures - Rips - Tears (Emergency)

Quantity: 1 EA

These deficiencies are typically caused by foot traffic, mechanical work, or simply by a waterproofing membrane that is at the end of it's service life and can no longer withstand the weathering and building movement.

The area surrounding the deficiency must be cleaned. A new piece of waterproofing membrane would be installed and sealed per industry standards.

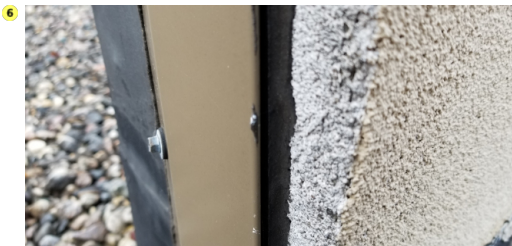
General - Counterflashing Caulk Failure (Remedial)

Quantity: 2 LF

Caulking at counter flashing is failing and allowing water in.

We will remove the old caulking, prime the area and install new NP-1 to ensure water tightness.

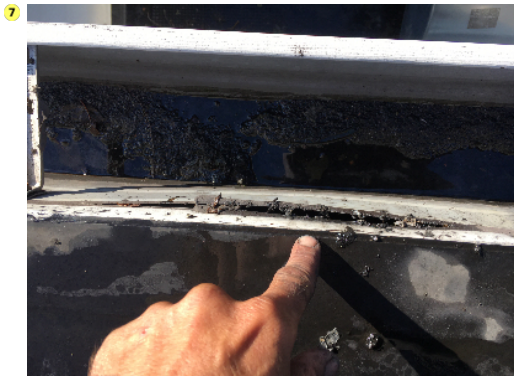
General - Drains/Scuppers Open (Emergency)

Quantity: 1 EA

Scupper / drain / gutters are open and allowing water in.

We will clean and prime the corner, then install new patch to ensure water tightness.

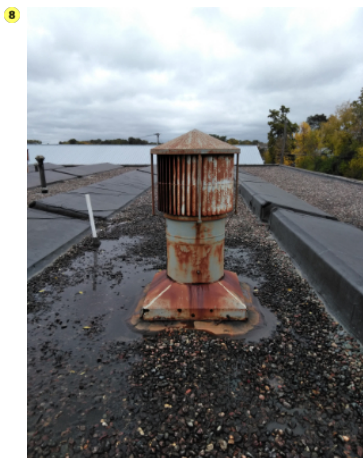
EPDM - Ponding (Remedial)

Quantity: 150 SF

A ponding water condition is typically due to a flaw in how the original roof was designed to flow to drains or the underlying insulation has collapsed due to age or weight and created a low lying area on the roof which is now holding water.

A ponding water condition is best corrected during a re-roof project. Outside of removing the existing insulation and starting with a new roof design, ponding water is difficult to correct.

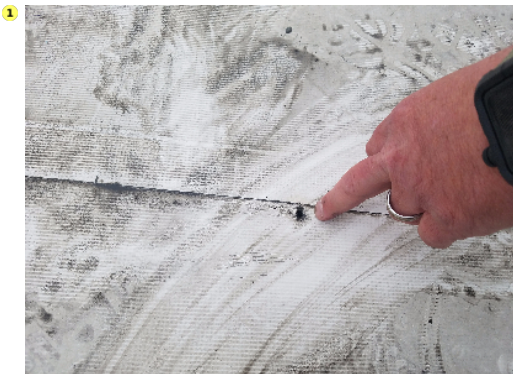
General - *Punctures - Rips - Tears (Emergency)

Quantity: 1 EA

These deficiencies are typically caused by foot traffic, mechanical work, or simply by a waterproofing membrane that is at the end of it's service life and can no longer withstand the weathering and building movement.

The area surrounding the deficiency must be cleaned. A new piece of waterproofing membrane would be installed and sealed per industry standards.

We highly recommend you address the puncture we found to extend the life of this roof system and avoid any significant damage.
